**Geological risk assessment of Amtoudi Agadir in southern Morocco:  
a key case for sustainable cultural heritage**

**Abstract** Medieval fortified granaries known as “agadirs” are very common in southern Morocco, being catalogued as world cultural heritage by UN. These Berber buildings (made of stones and tree trunks) usually located on rocky promontories, constitute historical testimonials related to the origin of Morocco and, as tourist attractions, have a positive impact on the local economy. The sustainability of these ancient monuments requires geological-risk evaluations of the massif stability under the agadir with the proposal of stabilization measures, and an architectonic analysis with appropriate maintenance of the structural elements. An interdisciplinary study including climate, seismicity, hydrology, geology, geomorphology, geotechnical surveys of the massif and diagnosis of the degradation of structural elements have been performed on the Amtoudi Agadir, selected as a case study. The main findings from this study are that the prevalent rocks used for construction (coming from the underlying substratum) are good-quality *arkosic* sandstones; the SW cliffs under the

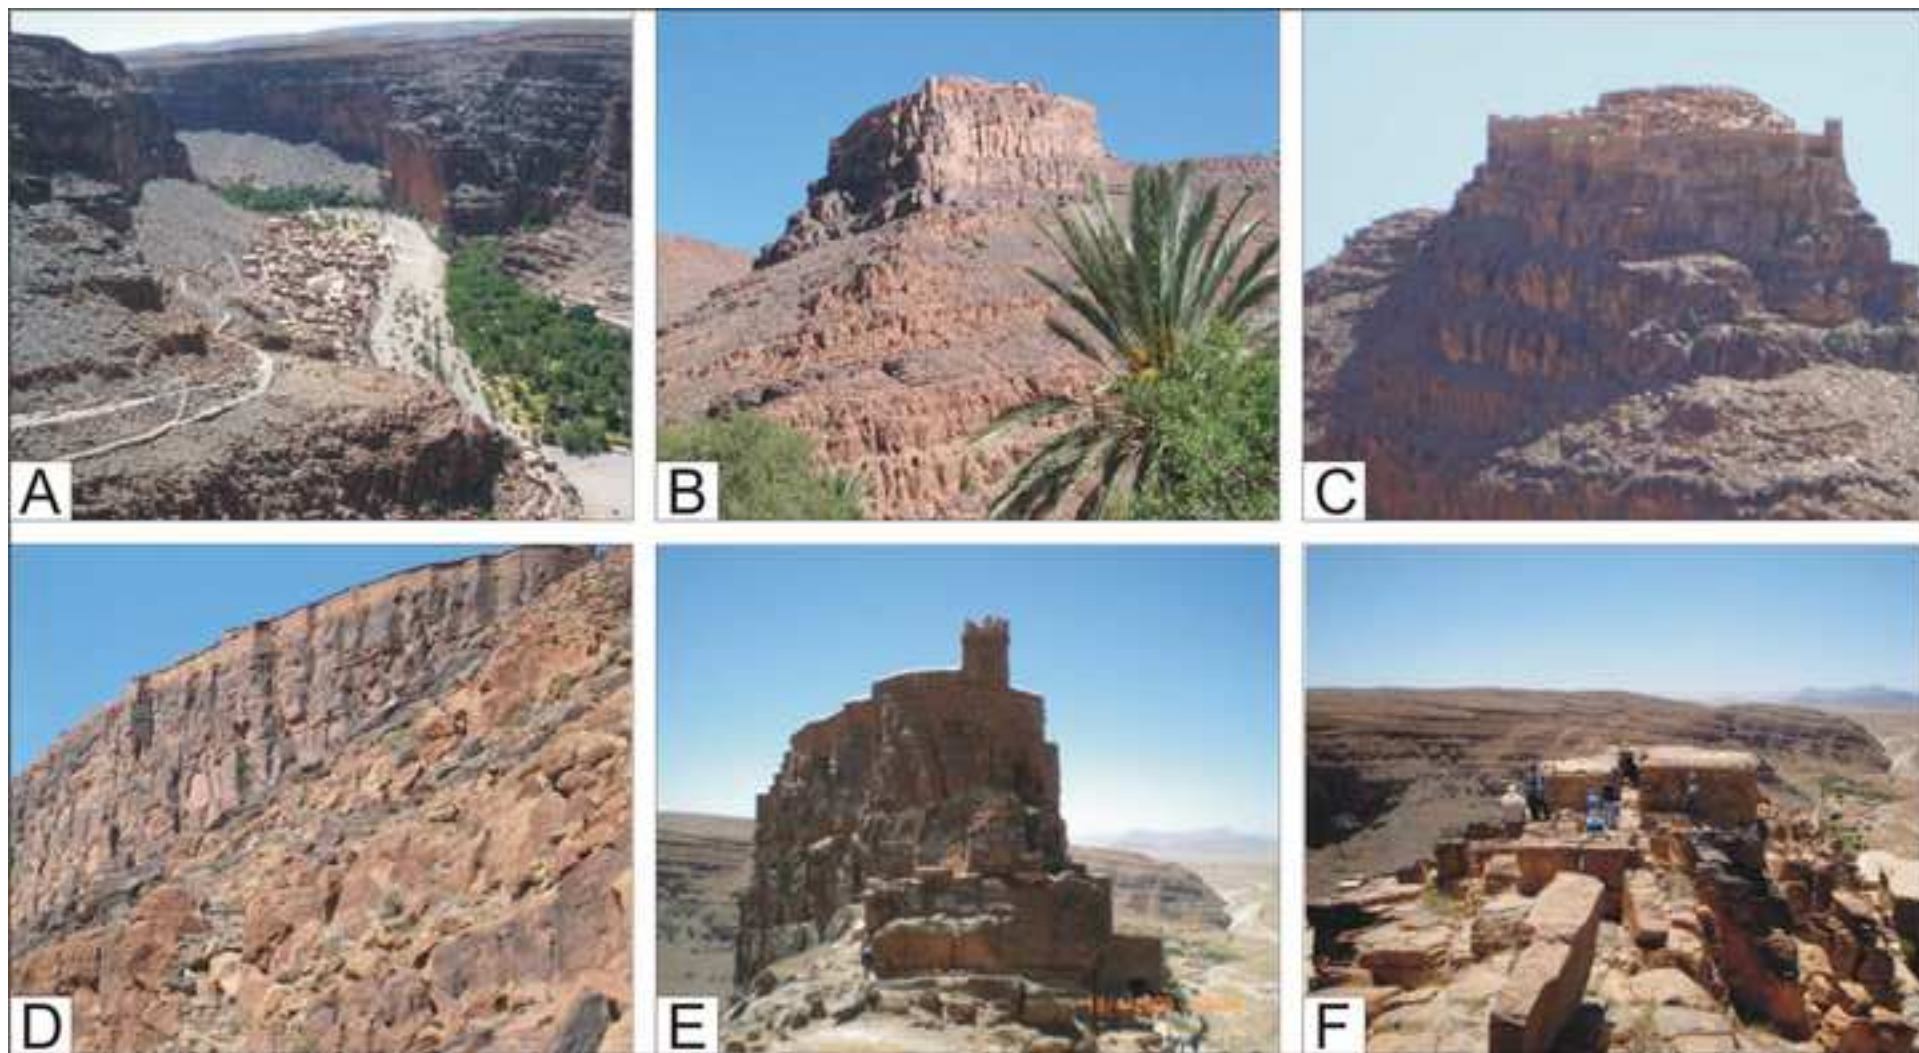
Figure 1  
[Click here to download high resolution image](#)

Fig. 1 – Photographic documentation of the Amtoudi area (village, oasis and agadir). **A**, Amtoudi village and oasis (view from the agadir); **B**, southwest view of the agadir from the Amtoudi village; **C**, close west view of the agadir from the Amtoudi village; **D**, southeast view of the sidewall of the agadir; **E**, northwest close view of the agadir; **F**, internal aspect of the agadir.

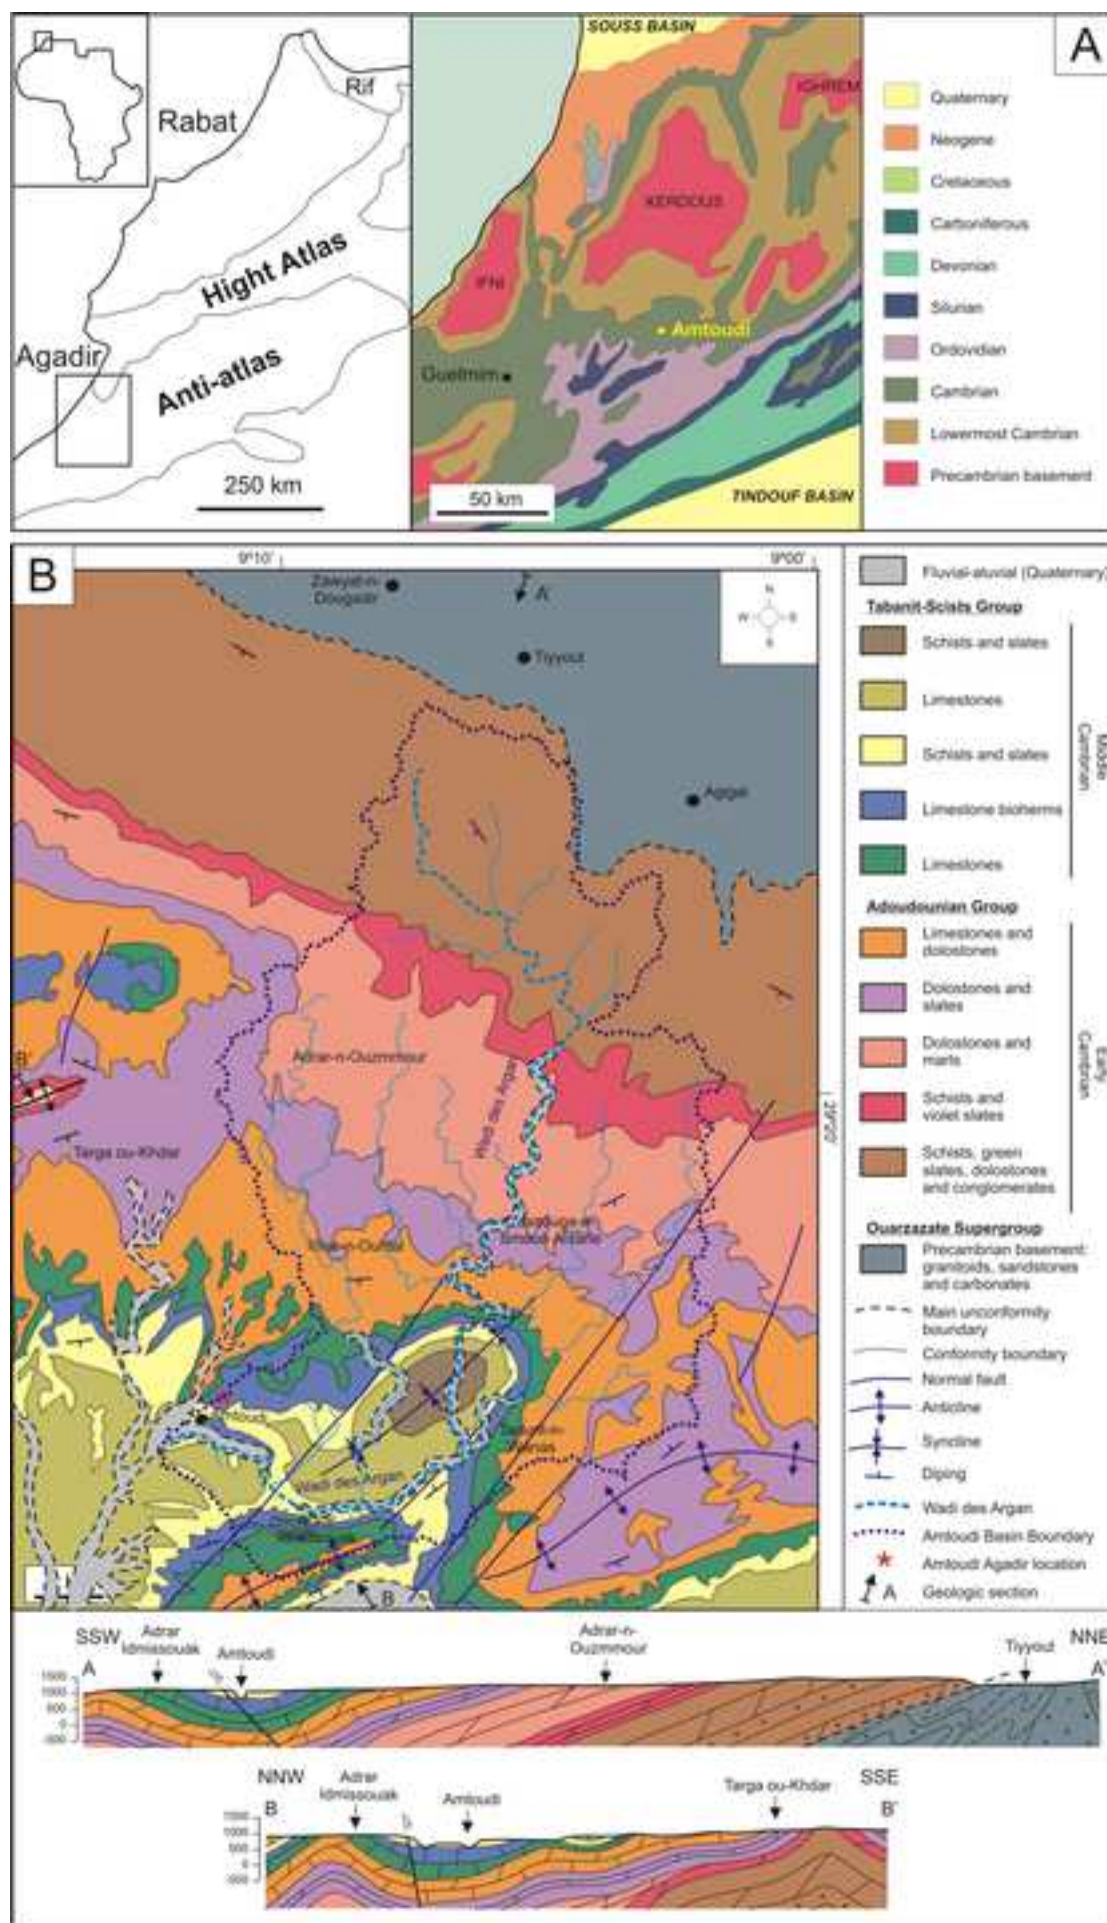
Figure 2  
[Click here to download high resolution image](#)

The study area is located at the outlet of the "Wadi des Argan" hydrological basin (9°01'-9°12' W and 29°12'-29°27' N) in the province of Guelmim in southern Morocco (Fig. 2). The area has a subtropical dry climate with a bimodal precipitation distribution (Schulz 2008). Most of the

At the basin scale, the main geological characters and tectonic structures are reported in Figure 2B. As elsewhere the stratigraphy of the Amtoudi region is characterized by: (i) Precambrian basement divided into different successions and separated by major unconformities (Choubert 1963; Naidoo et al. 1991; Ennih and Liegeois 2001); and (ii) Palaeozoic sedimentary cover slightly deformed during the Hercynian orogenesis. A Palaeozoic suite covers the Precambrian basement by a transgressive marine succession that widely outcrops in southern Morocco. The thickness of the Palaeozoic stratigraphic record may exceed 10 km in the westernmost Anti-Atlas (Tiznit region) but can be less than 5-6 km in the easternmost Anti-Atlas (Tafilalt region) (Burckard et al. 2006; Soulaïmani and Burckard 2008). Synthetic stratigraphic columns and chronostratigraphy of the Proterozoic basement and Palaeozoic sedimentary cover of the Anti-Atlas is furnished by Burckard et al. (2006) and Soulaïmani and Burckard (2008), to which we will refer.

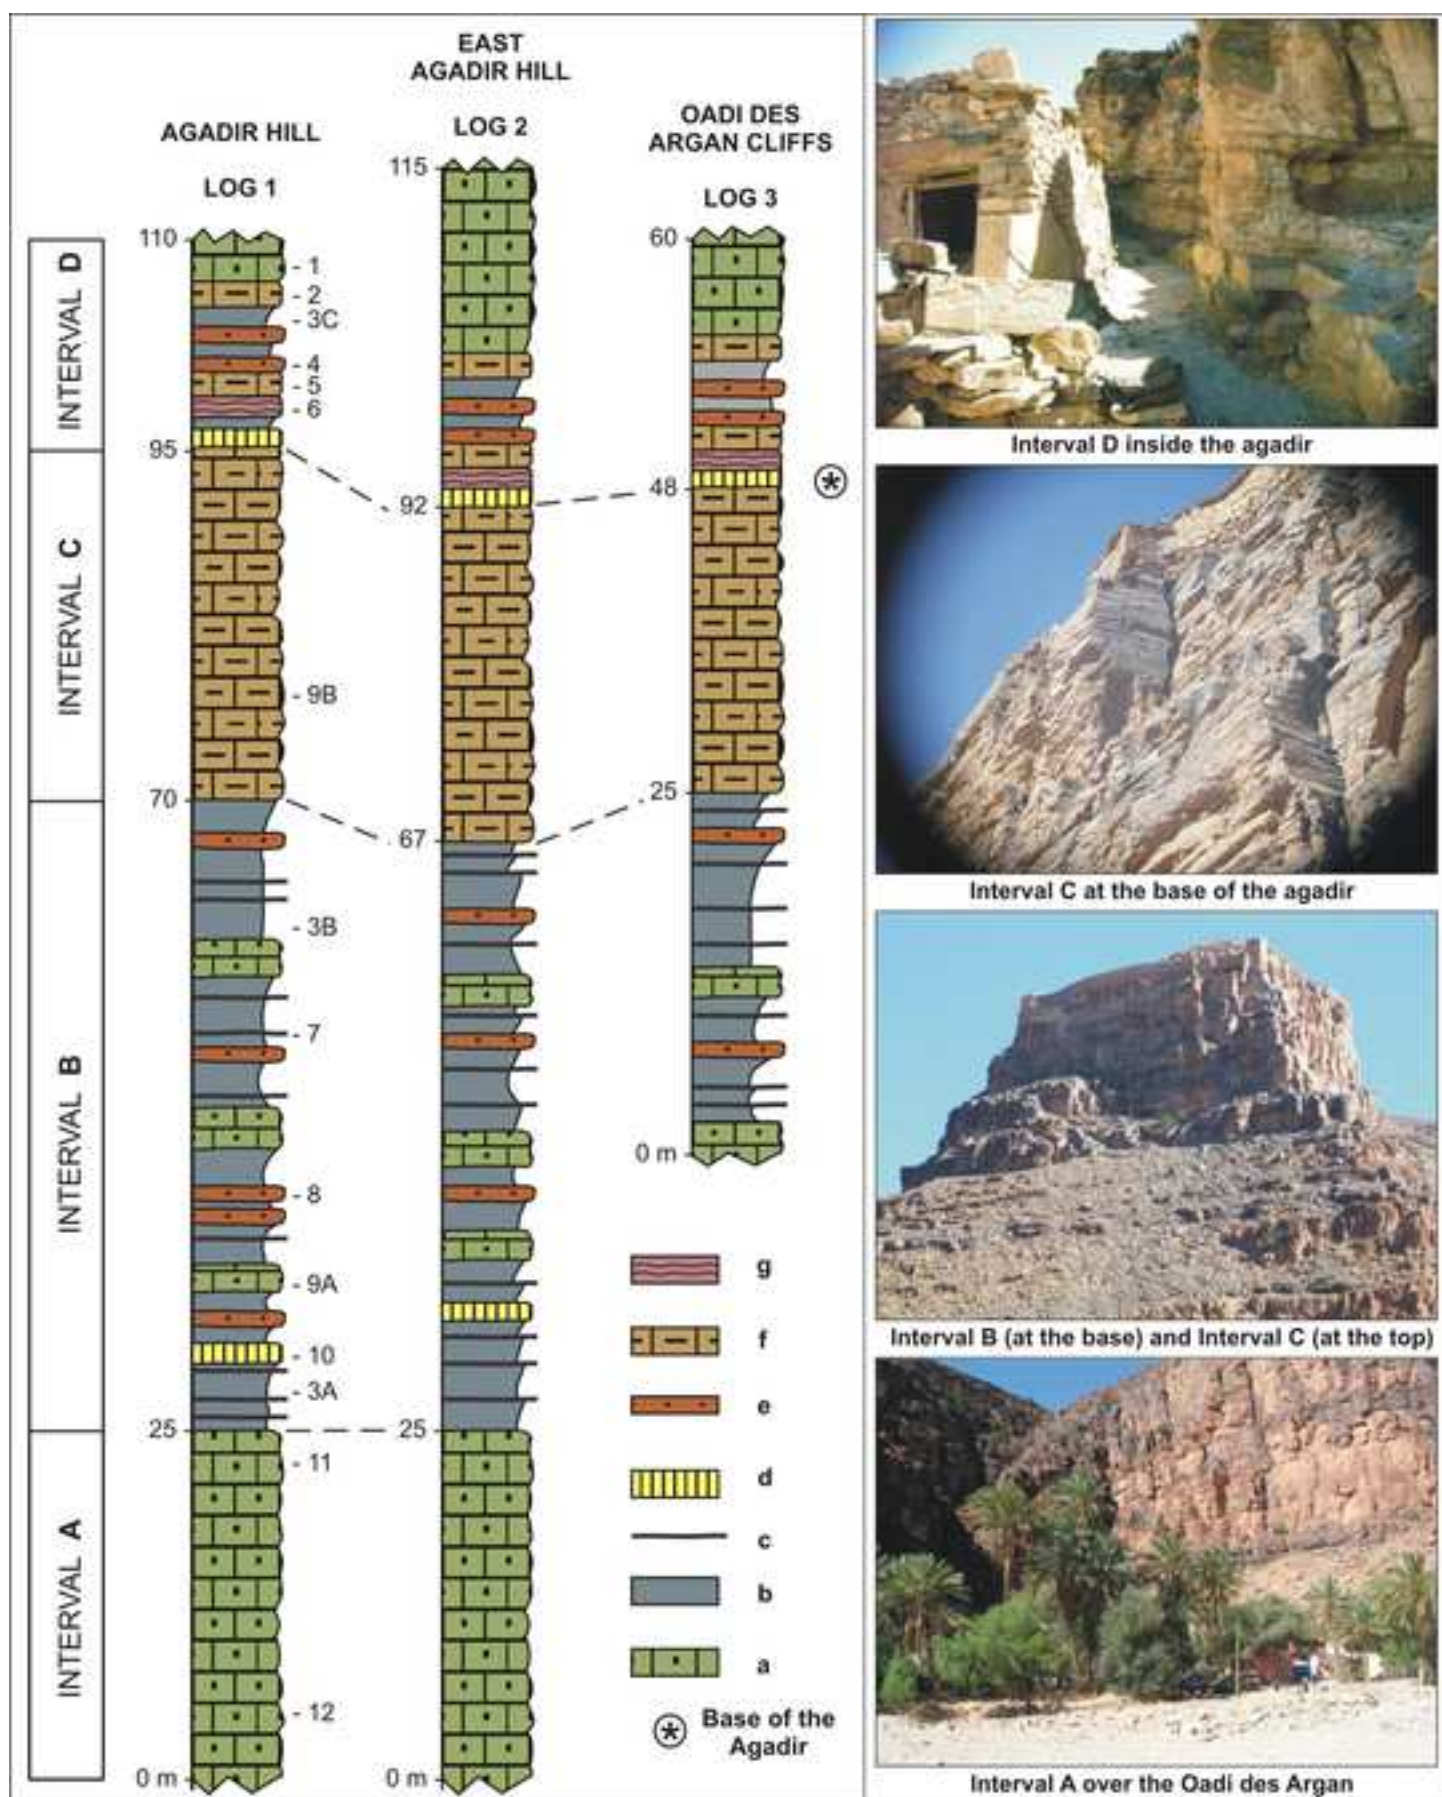
Figure 3  
[Click here to download high resolution image](#)

(1) **Interval A** (logs 1 and 2; Fig. 3) constitutes the lowest portion of local succession with thicknesses of over 25 m and is dominant in the Amtoudi area. It consists of brownish recrystallized limestones (*wackestone/grainstone*) characterized by massive, detritic, silicified, dolomitized limestones with lamination, asymmetric ripples and irregular stratification; thickness is between 0.1 to 1.5 m. Colour variations have been observed and they correspond to size changing (from very fine to sandy) of grains.

(2) **Interval B** (Logs 1, 2, and 3; Fig. 3), prevalently *claystones/siltstones*, is characterized by darkish micaceous argillites, stratified, laminated, and silicified with massive dark-brownish arenites and *siltstones* interbedded. Three clearly distinguishable beds of *wackestones/grainstones* and some thin beds of very fine to coarser grey-green quartzarenites and of homogeneous silicified limestones are also present. Interval thickness is about 55 m.

(3) **Interval C** (logs 1, 2, and 3; Fig. 3) immediately crops out under the agadir, constituting its geologic foundation. It consists of laminated arenites (*arkosic sandstones*) showing a bed varying in thickness from 1.0 to 1.5 m. These arenites are greyish-greenish in colour, from massive to thinly stratified, very fine-grained and often covered with a black patina: they show great hardness due to the siliceous composition. Laminated beds with chaotic, heterogeneous whitish pelites are also interbedded. The interval thickness is about 25 m. Fe-Mn mineralizations and glauconie have been observed.

(4) **Interval D** (logs 1, 2, and 3; Fig. 3) is prevalently detected inside of the agadir for a thickness over 12 m. It starts with blackish and purple stratified *schists*, with schistosity evidenced by diffusion of the brightest flakes of mica surfaces, fine-grained, and centimetric in thickness; pyrite is quite common. This is followed by an alternation of previous petrofacies as: *wackestones/grainstones*, *claystones/siltstones* and *arkosic sandstones*.

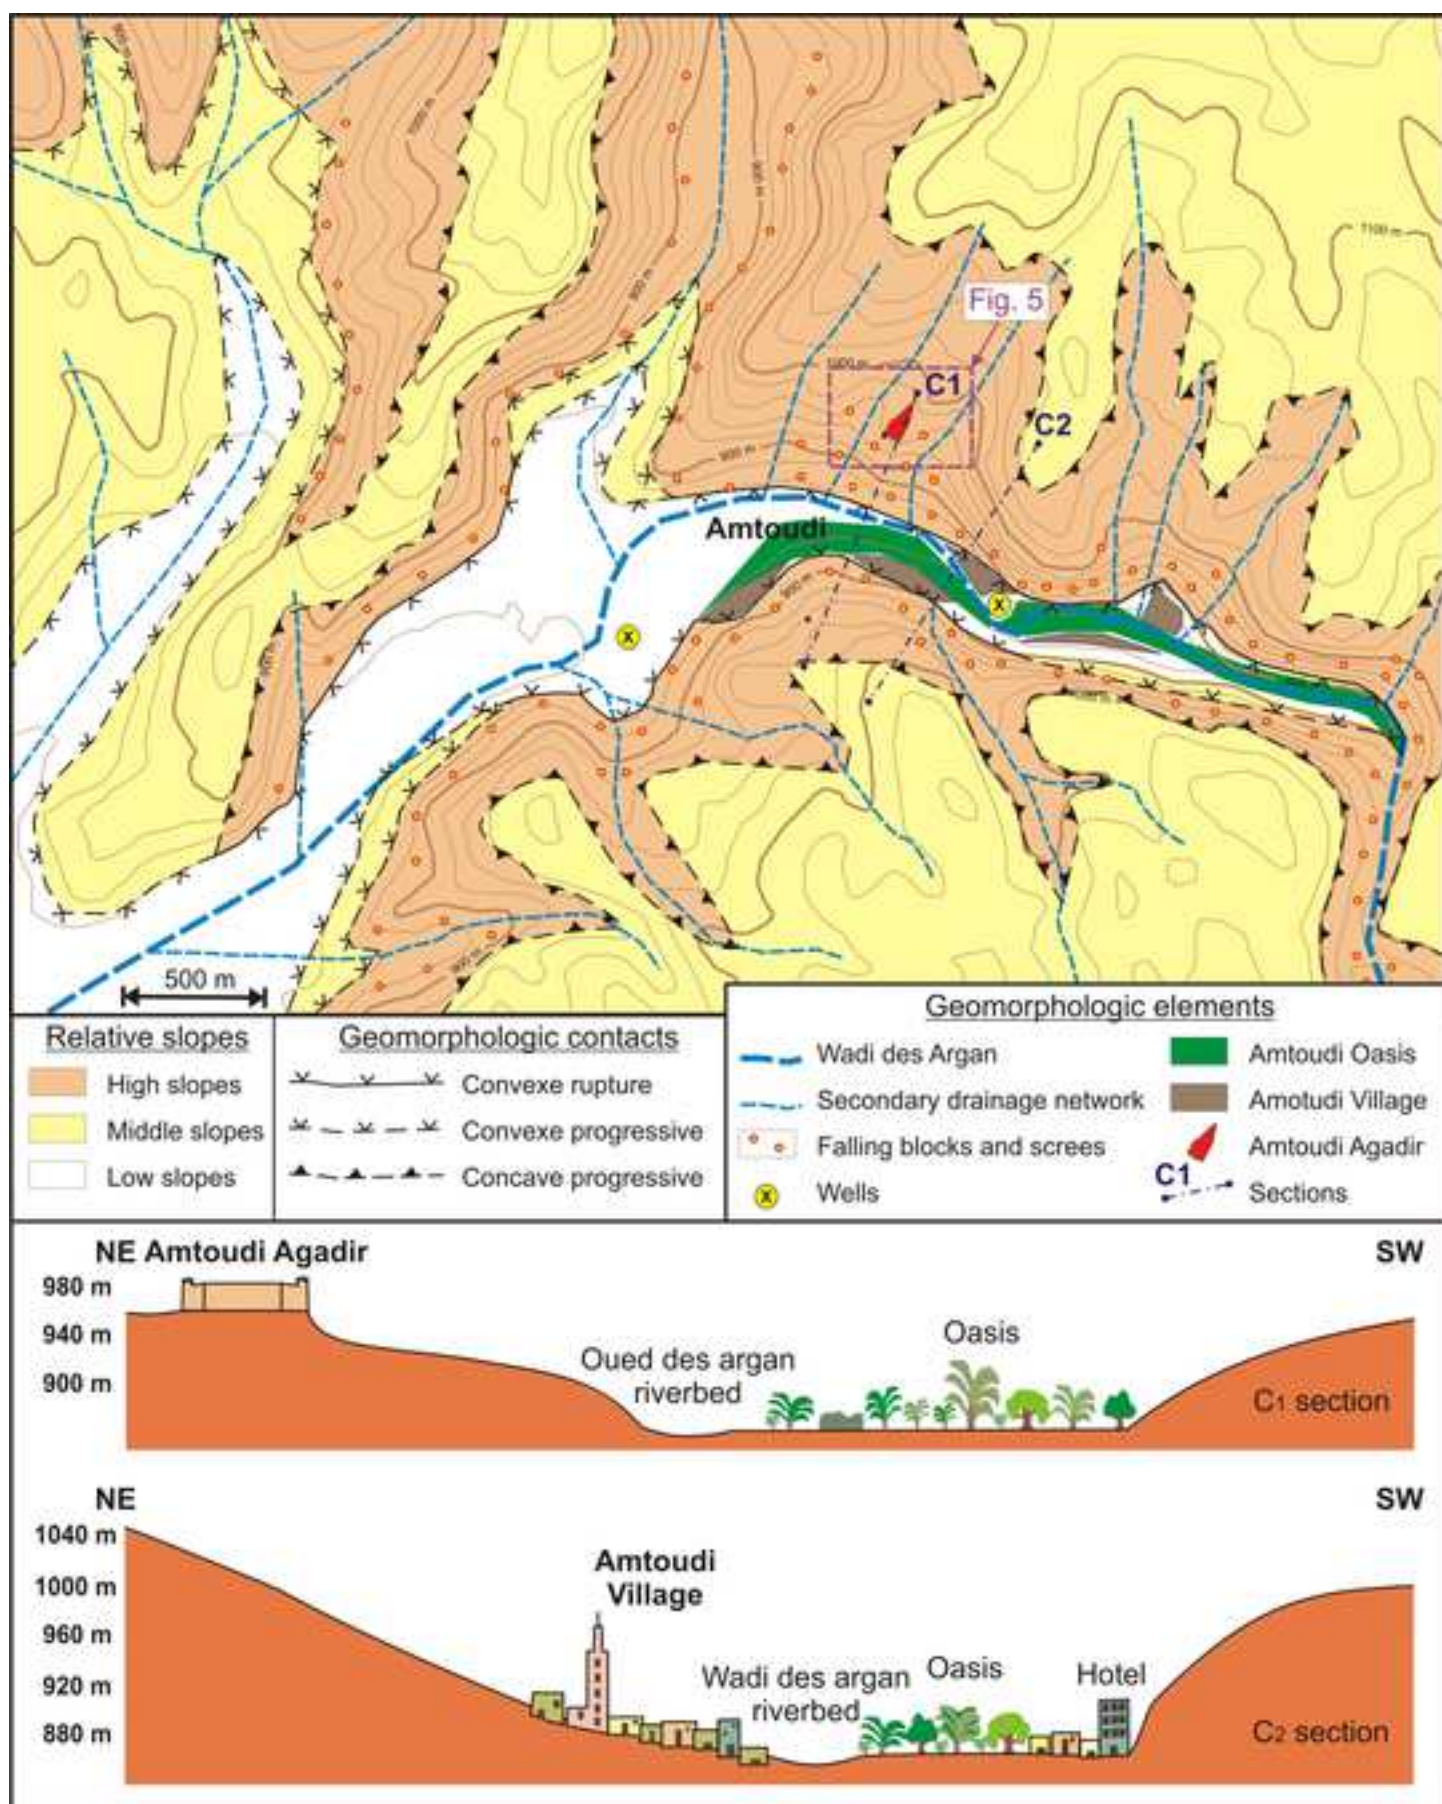
Figure 4  
[Click here to download high resolution image](#)

The geomorphologic map drawn for the area (Fig. 4) includes slopes (low, middle and high), geomorphologic contacts (concave or convex, progressive or rupture), main and secondary drainage network, and such geomorphologic elements as fallen blocks. These aspects are closely related to the geological risk, making it clear that the agadir site, located on a high slope with fallen blocks, is affected by gullies of the secondary drainage network. The absence of clayish and gypsum rocks removed the possibility of halokinetic risk, though risks related to gravitational and fluvio-alluvial processes remain.

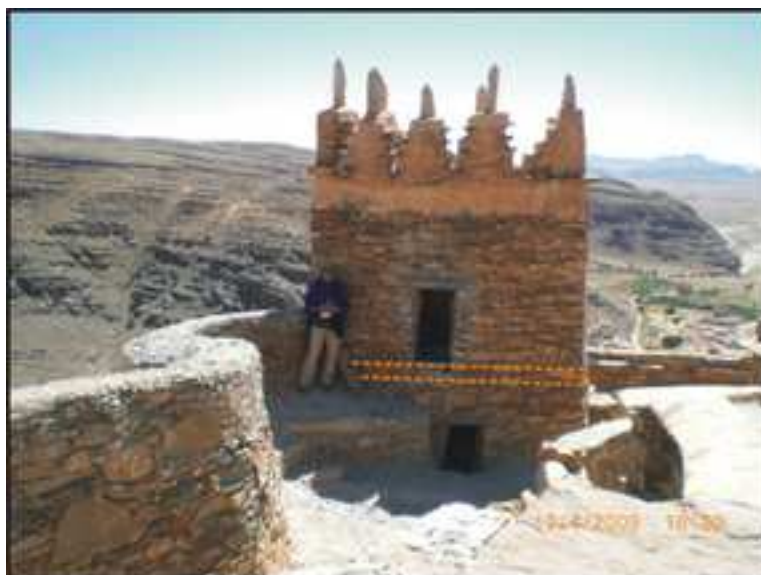
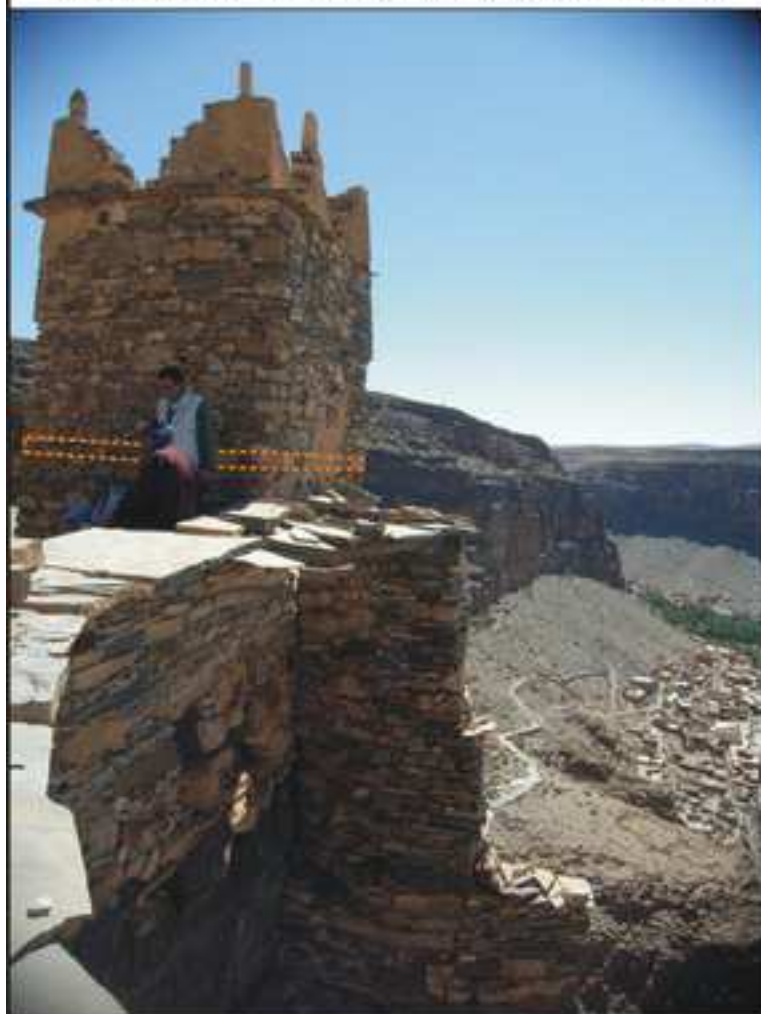
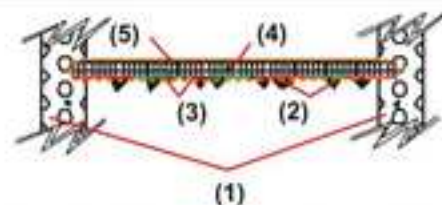
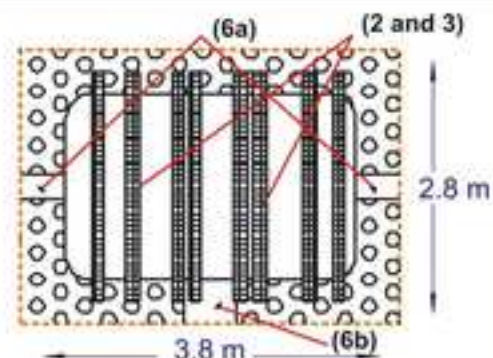
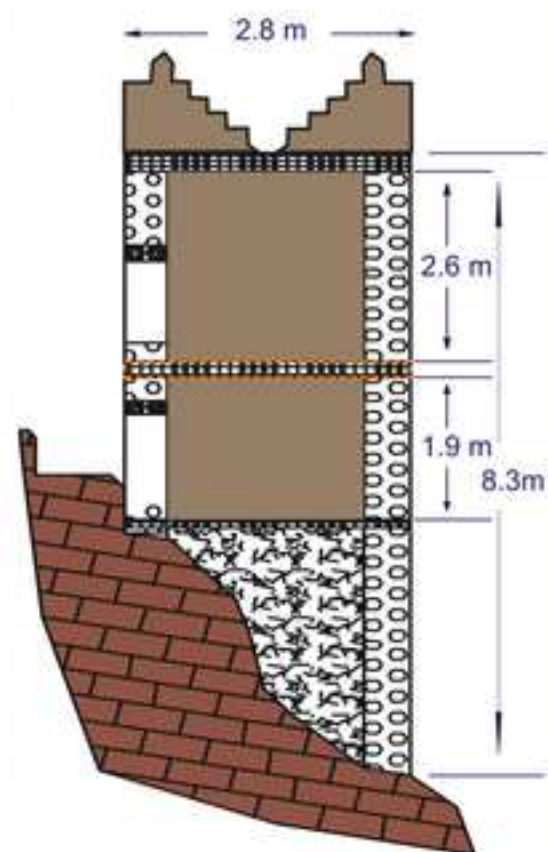
Figure 6  
[Click here to download high resolution image](#)

Data from the different architectonic elements, materials used and existing failures were recorded in order to assess the stability of Amtoudi Agadir. Specifically, in order to perform concrete calculations on the ceiling-structure safety, the SE tower of the agadir was sketched (see Fig. 6).

Front view of the SE tower of the Amtoudi Agadir

Side view of the SE tower of the Amtoudi Agadir

Detailed sketch front view of the ceiling structure of the tower

Sketch top view of the ceiling structure

Sketch side view of the tower

- (1) Masonry wall (0.45 m thick) linked by clay and lime mortar
- (2) Palm and argan wooden beams showing wood rot in the embedment zone
- (3) Flat stones (0.03 m thick) supporting the gravelly fill of the ceiling structure

- (4) Gravel fill (0.15 m thick) linked with clay and lime mortar 0.15 m thick
- (5) Waterproof layer (0.01 m thick) made of lime and sand
- (6) Wall openings in the tower: 6a windows; 6b access dor

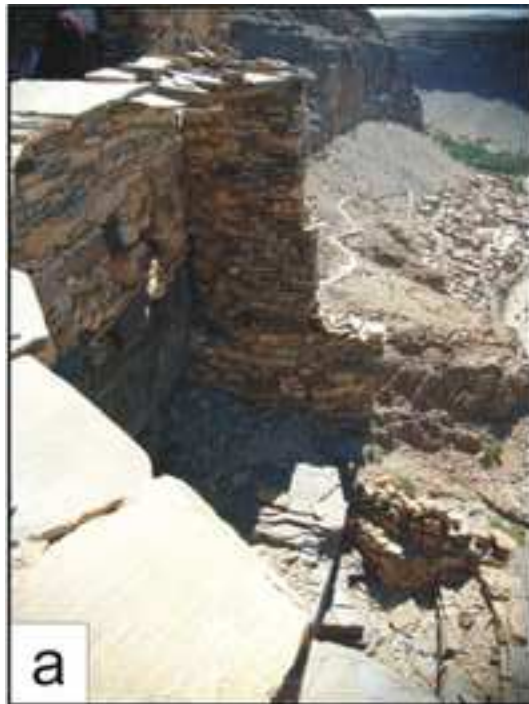
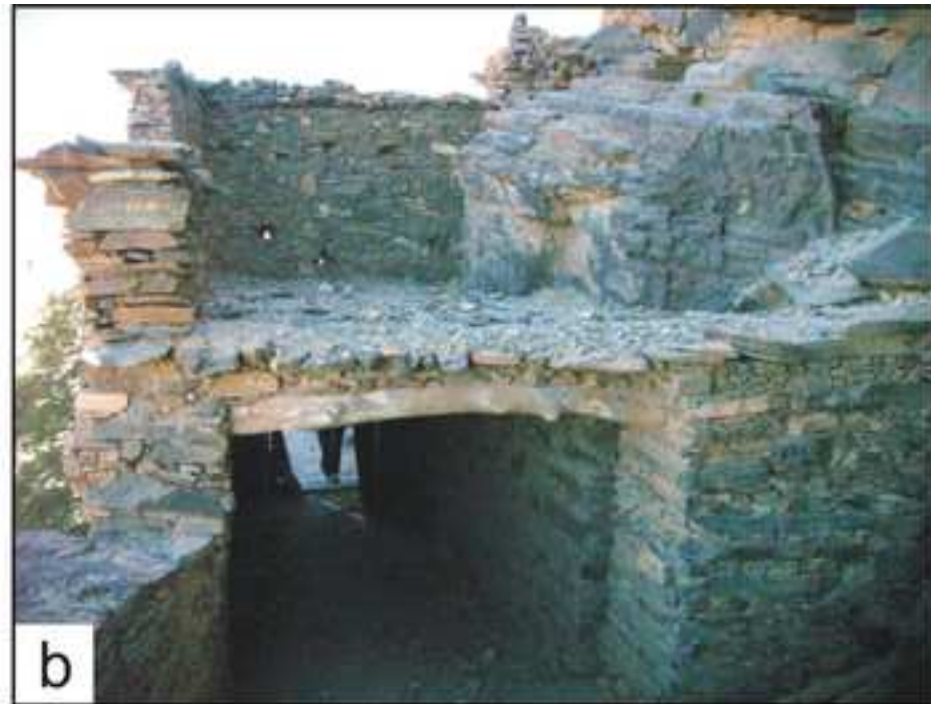
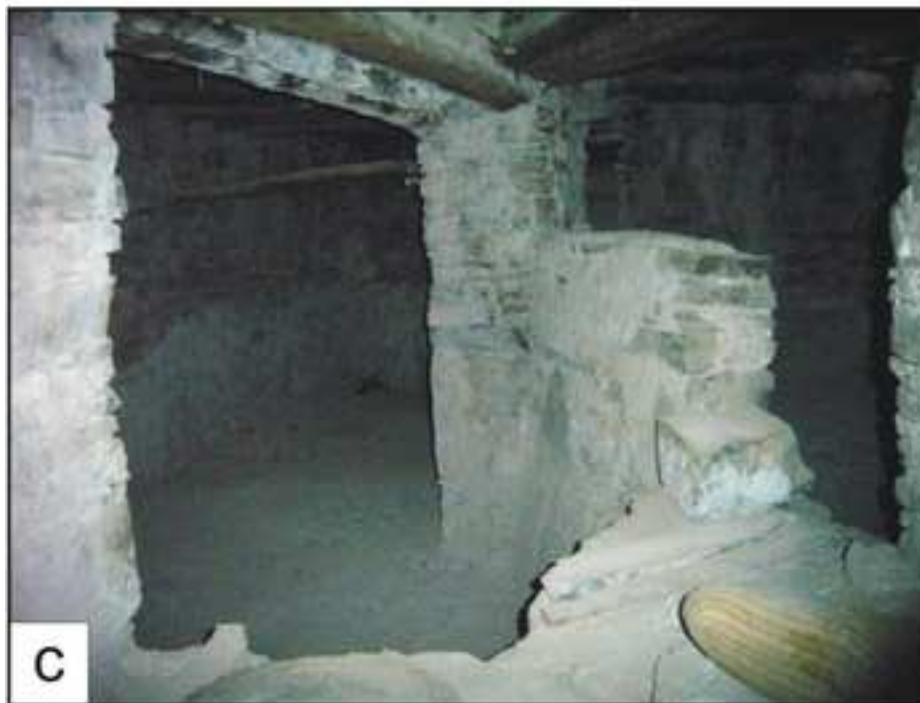
Figure 7  
[Click here to download high resolution image](#)

Fig. 7 – Load-bearing structural elements in the Amtoudi Agadir: a) exterior walls and buttresses; b) load-bearing walls; c) masonry pier; d) stone column.

- Gravity walls. Usually appearing on the exterior sides of the agadir, are made up of the accumulation of stacked flat rock fragments. These walls lack interlocking joints in the masonry, have no mortar, and in some cases resemble a small, rough ashlar. The dimensions (height and thickness) are a meter or two (Fig. 7a)

- Buttresses. In some places of the exterior sides of the agadir, gravity walls or towers are buttressed (Fig. 7a) and are also composed of stacked flat rock fragments in a similar way to gravity walls.

- Load-bearing walls. These (Fig. 7b) are used to partition rooms and to support the ceilings, the vast majority of the load-bearing structural elements being in the interior of the agadir. These, like the external walls, are built by stacking flat rock fragments, but in this case joined by a clay and lime mortar. These walls usually measure 0.30 to 0.50 m thick and less than 3 m high.

- Isolated pillars. These, much less frequent in the agadir, support part of the ceiling load, allowing the circulation within the enclosed space. These isolated pillars in some cases consist of piers (Fig. 7c) and in some others are columns made of a monolithic prismatic stone with centrimetric diameters (Fig. 7d).

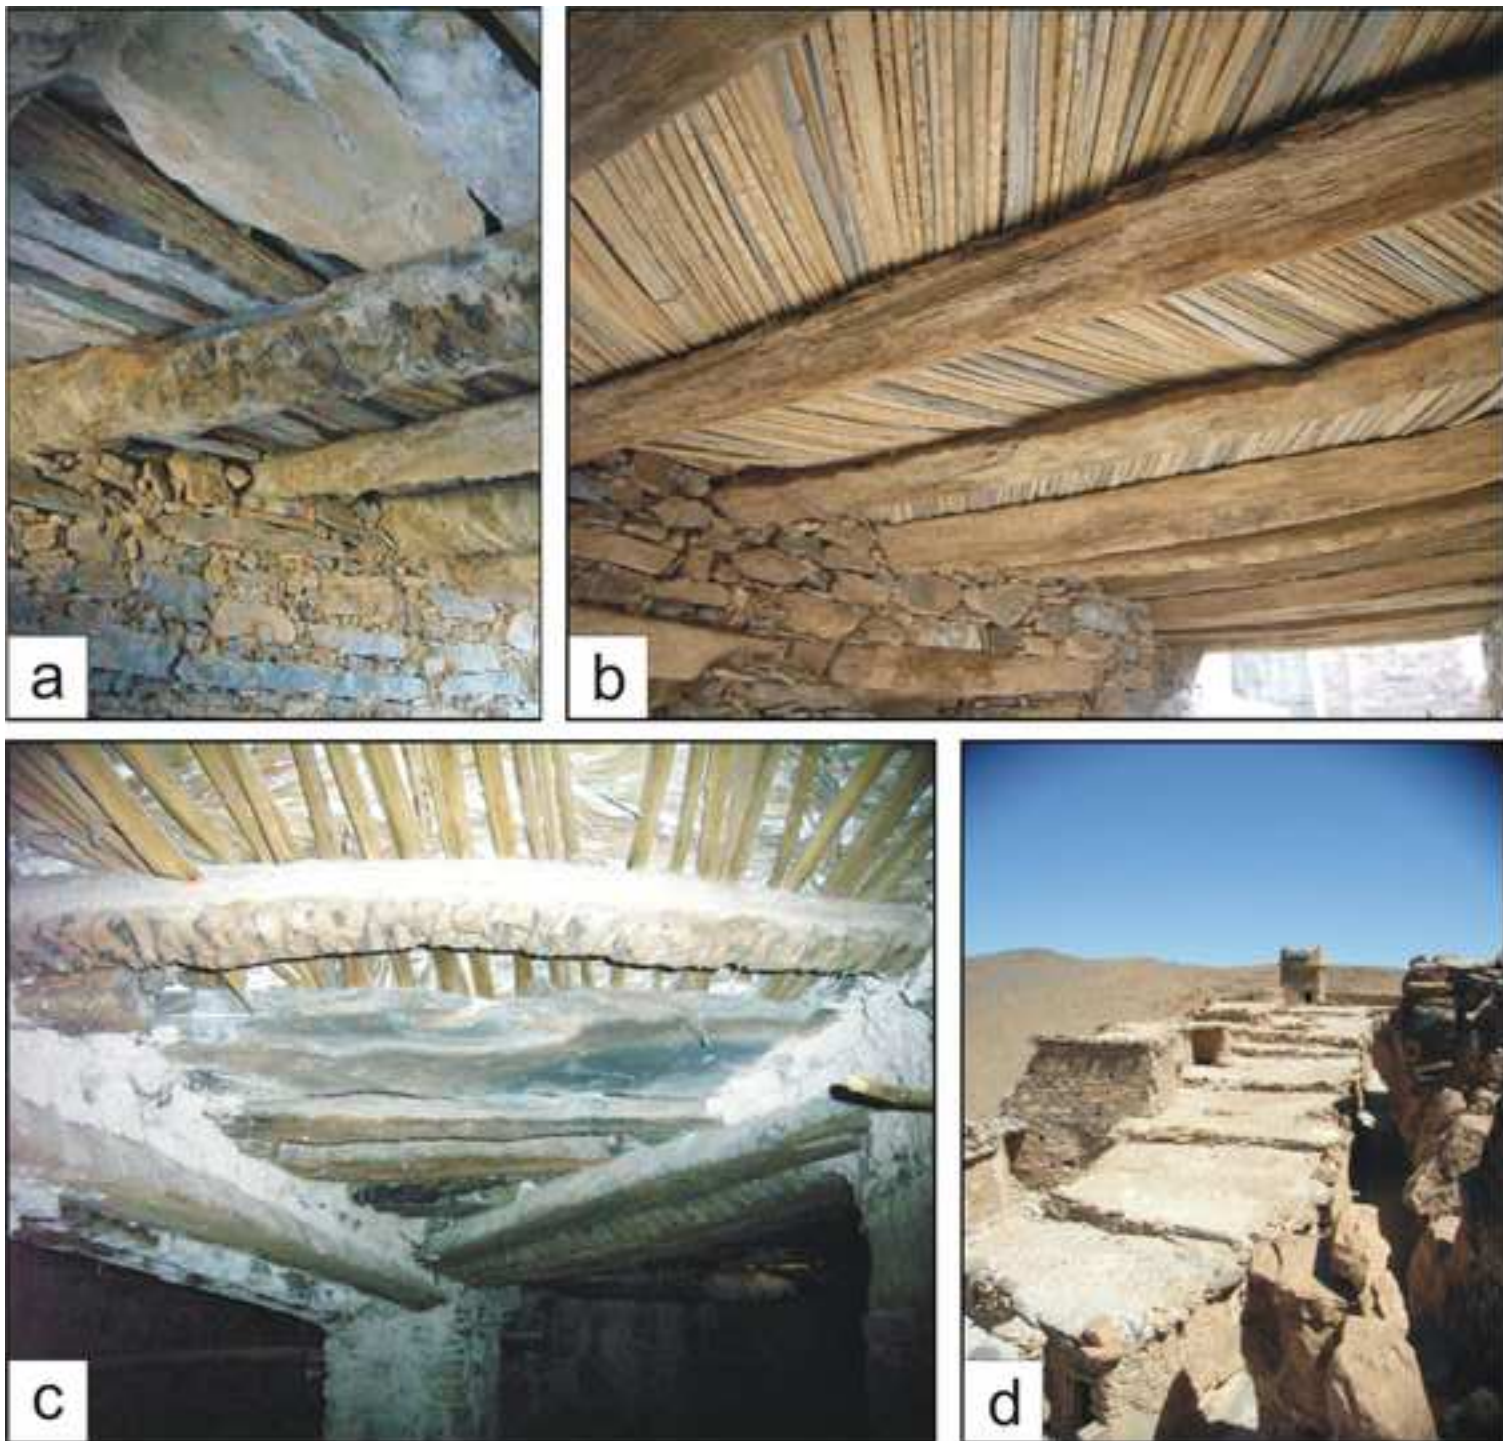
Figure 8  
[Click here to download high resolution image](#)

- Ceiling structures. a unique kind of ceiling structure was found (Fig. 8a, 8b and 8c) with beams resting on the load-bearing walls and flat stones over the beams or interlaced palm leaves (Fig. 8a, 8b and 8c). These structures, over the flat stones, usually carry a gravelly fill topped by a thin layer of mortar made of clay and lime. This layer is of better quality and thicker in the roof structure (Fig. 9d).
- Lintels. These, appearing over the openings in the walls for windows and doors, consist of sturdier beams embedded in the wall. These beams, meant to support the weight of the wall above the opening of the door or window, are made of solid argan timber or stone, both square in section and having a width reaching 20 cm.

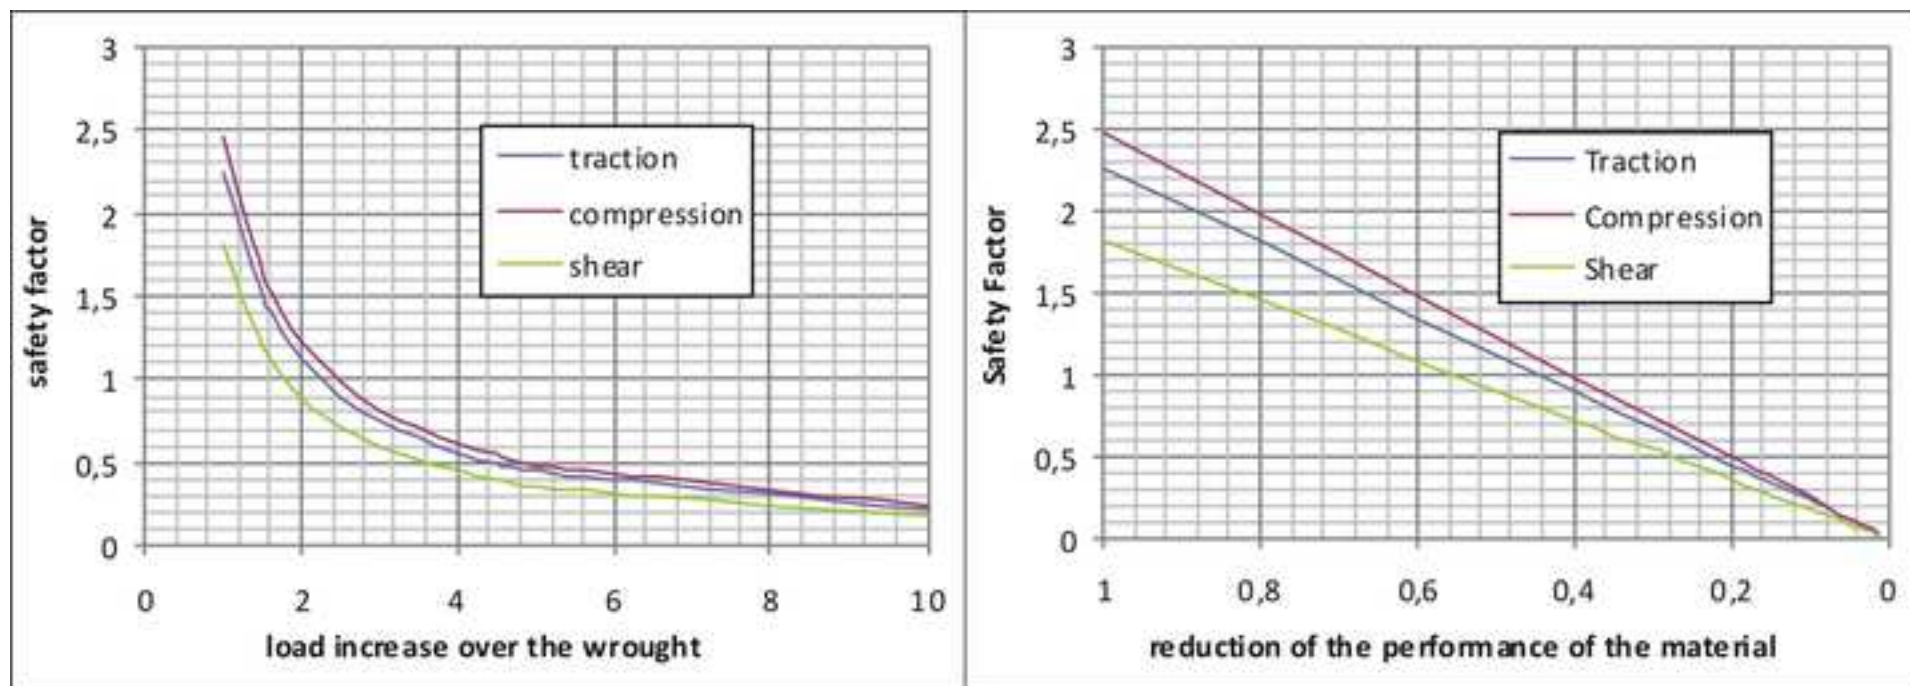
Figure 10  
[Click here to download high resolution image](#)

4 For the calculation, two conditions were changed (Fig. 10): (1) the load over the ceiling structure  
5 was progressively increased up to 10-fold the normal value (left part of Fig. 10); (2) the  
6 performance of the material of the beam was reduced (right side of Fig. 10) due to rot, insect  
7 attack, or material fatigue (= reducing the flexural elastic modulus).

15 In the second case (when the flexural elastic modulus of the palm is reduced by rot, insect  
16 attack, or material fatigue) the behaviour in the three cases (traction, compression or share) is  
17 different, shearing being the worst situation. In the case of shear, when a reduction of a 20% in  
18 performance occurs, the safety factor falls below 1.5. When the reduction is about 50%, the safety  
19 factor is below 1. The other two cases (compression and traction) show similar trends, the safety  
20 factor going below 1.5 for a reduction of a 40% in the performance of the material, and below 1 for  
21 a reduction of a 60%.

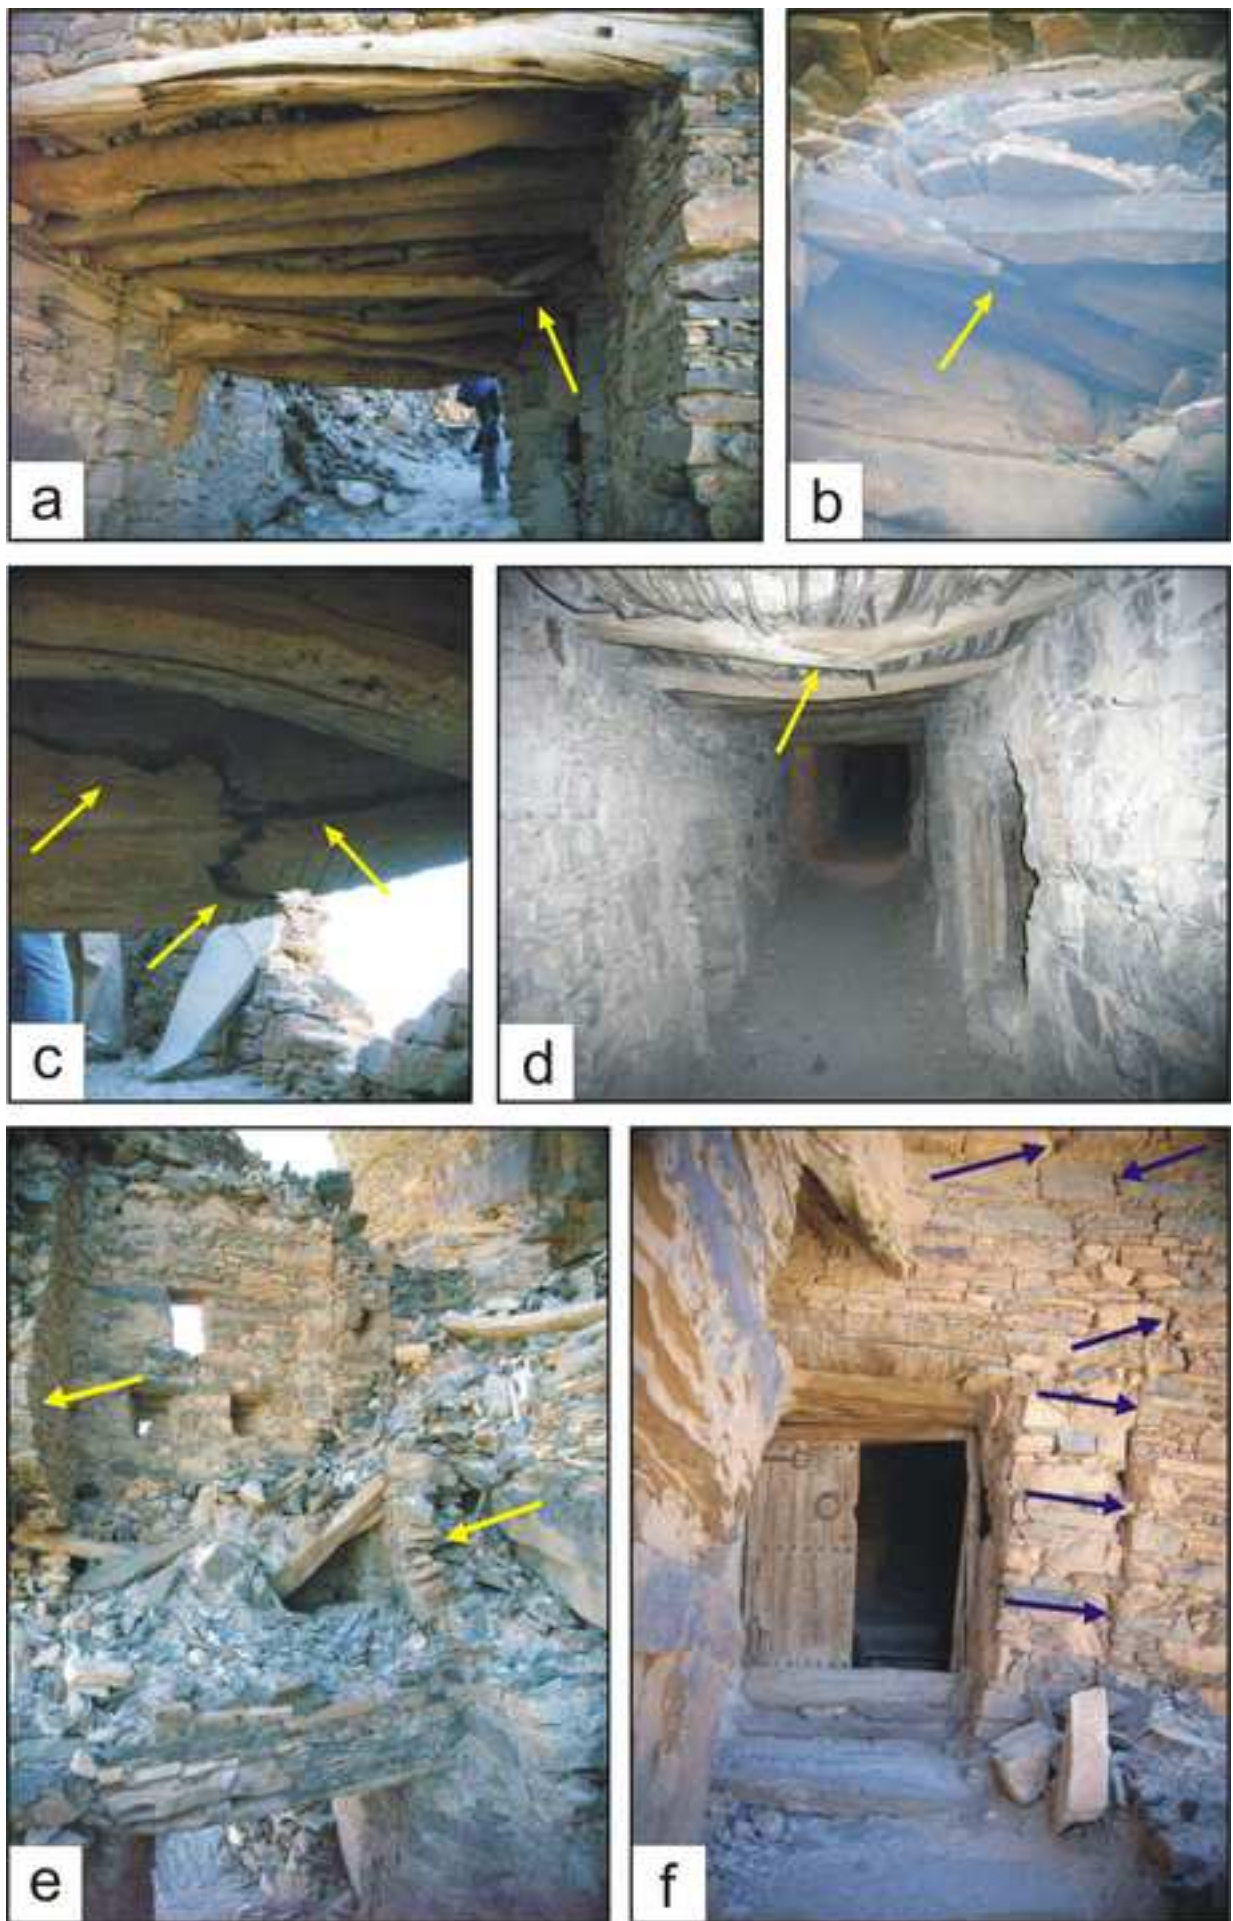
Figure 11  
[Click here to download high resolution image](#)

22 The most important failures that can be observed in Amtoudi Agadir occur on the structural  
23 walls and on the beams of the ceiling structures. In both cases the problems are due to poor  
24 construction and maintenance, as explained in Table 6 and depicted in Figure 11.

Fig. 11 – Failures of ceiling structures and walls in the Amtoudi Agadir: **a**, ceiling structure with bent or sheared beams (see arrow); **b**, Detail of sheared stone beam due to excess of load; **c**, Detail of argan wooden beam sheared by flexure due to excess of load; **d**, ceiling structure with palm beam sheared by flexure; **e**, buckled walls having curved surfaces (see arrows) due to being

1 too thin; **f**, tension crack due to lack of interlocking joints in the masonry or lack of mortar locking  
2 the stones.  
3  
4 Table 1 - Expressions used to evaluate the concentration time (T) of the “Wadi des Argan”  
5 hydrological basin.  
6  
7 Table 2 - Main petrofacies recognized in the study area and micro-photographic documentation.  
8 Petrographic classification according to Wentworth (1922) (*claystones/siltstones*); Fettes and  
9 Desmons (2007) (*schist*); Gazzi et al. (1973) (*arkosic sandstones*), and Dunham (1962)  
10 (*wackestones/grainstones*).  
11  
12 Table 3 – Geo-mechanics properties of the unconformity systems affecting the Amtoudi massif.  
13  
14 Table 4 - Classification of the Amtoudi massif according to the slope orientation.  
15  
16 Table 5 - Safety factors for planar sliding model.  
17  
18 Table 6 - Failures of the architectonic elements in the Amtoudi Agadir.  
19

13 **(d)** In some of the worst cases, a bridging through ceiling structures is needed in some walls  
14 each 3 m of height to avoid long stretches of wall without support (weak under conditions of  
15 wind or earthquake).

16 **(e)** A review of certain ceiling structures is recommended: in some cases a higher number of  
17 beams is needed for a better weight distribution of the ceiling structure.

18 **(f)** To avoid troubles due to irregular geometry (curve) of the beams, the use of straight trunks  
19 for the beams is recommended. When possible, it is better to use stone than wood; when not,  
20 wooden beams that are warped, fractured, rotten, or attacked by insects should be replaced.

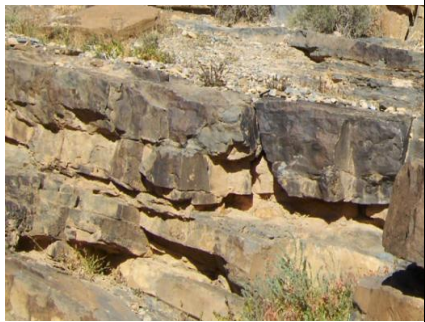
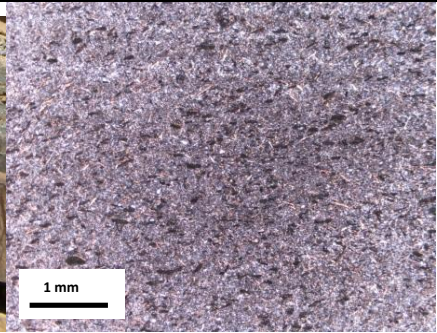
<p><b>Claystone/Siltstone</b> (Intervals B and D; samples 3A, 3B, and 3C)</p> <p><b>Claystone:</b> characterized by clayey matrix and a coarse fraction with muscovite and coarse and oriented chlorite.</p> <p><b>Siltstone:</b> shows a clayey matrix very rich in fine grains of quartz. Few opaque minerals (Fe-oxides and pyrite) are also present.</p>
